The Road Inventory of Crescent Lake National Wildlife Refuge Ellsworth, NE

Prepared By:
Federal Highway Administration
Central Federal Lands Highway Division
May 2008

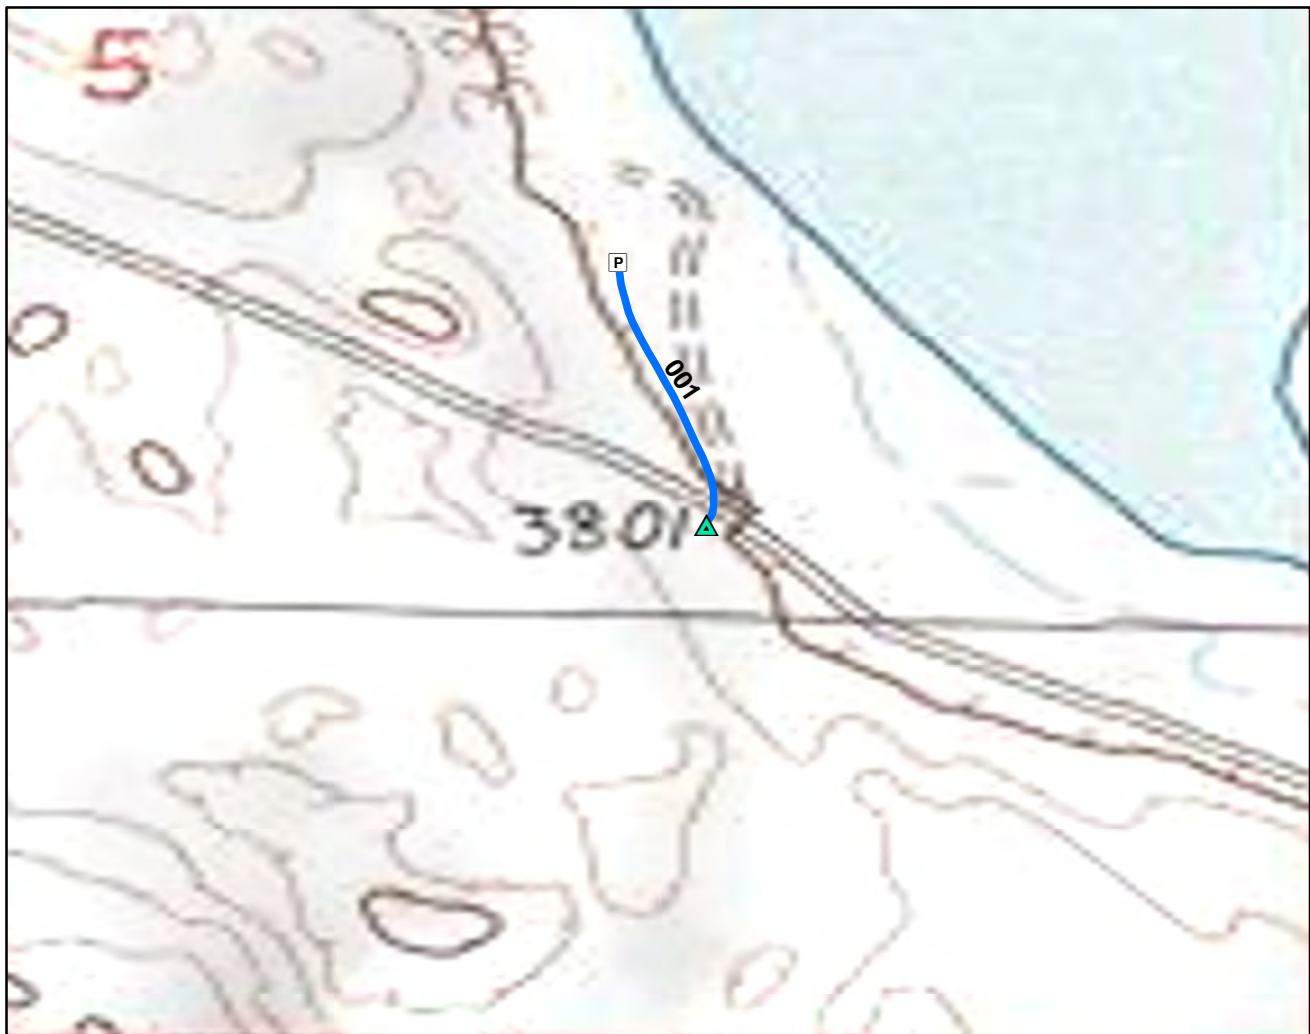
ROUTE: 013 West Mail Road TOTAL LENGTH: 5.10 Miles

Section Number	006				
Section Length (miles)	0.54				
Inspection Date	5/13/2008				
Section Information					
Surface Type	Gravel				
Number of Lanes	2				
Roadway Width (feet)	20				
Roadway Condition Information					
Condition	Good				
Remaining Service Life (years)	7				
Cost Estimate	\$900				
CRV	\$378800

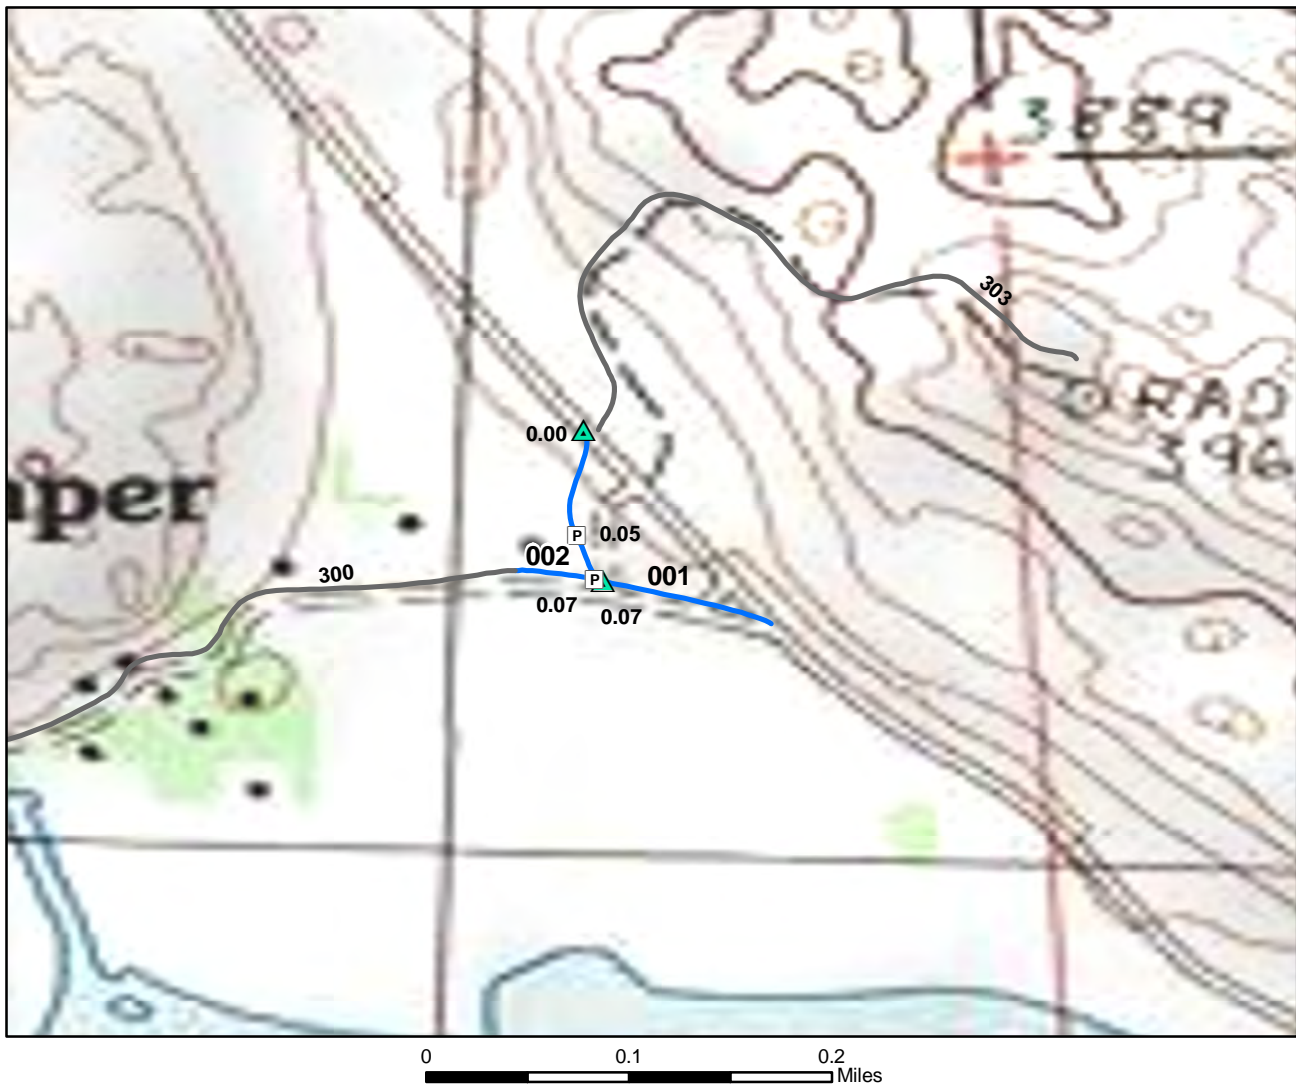
Section Number	001				
Section Length (miles)	0.14				
Inspection Date	5/13/2008				
Section Information					
Surface Type	Native				
Number of Lanes	1				
Roadway Width (feet)	10				
Roadway Condition Information					
Condition	Excellent				
Remaining Service Life (years)	10				
Cost Estimate	\$0				
CRV	\$49500

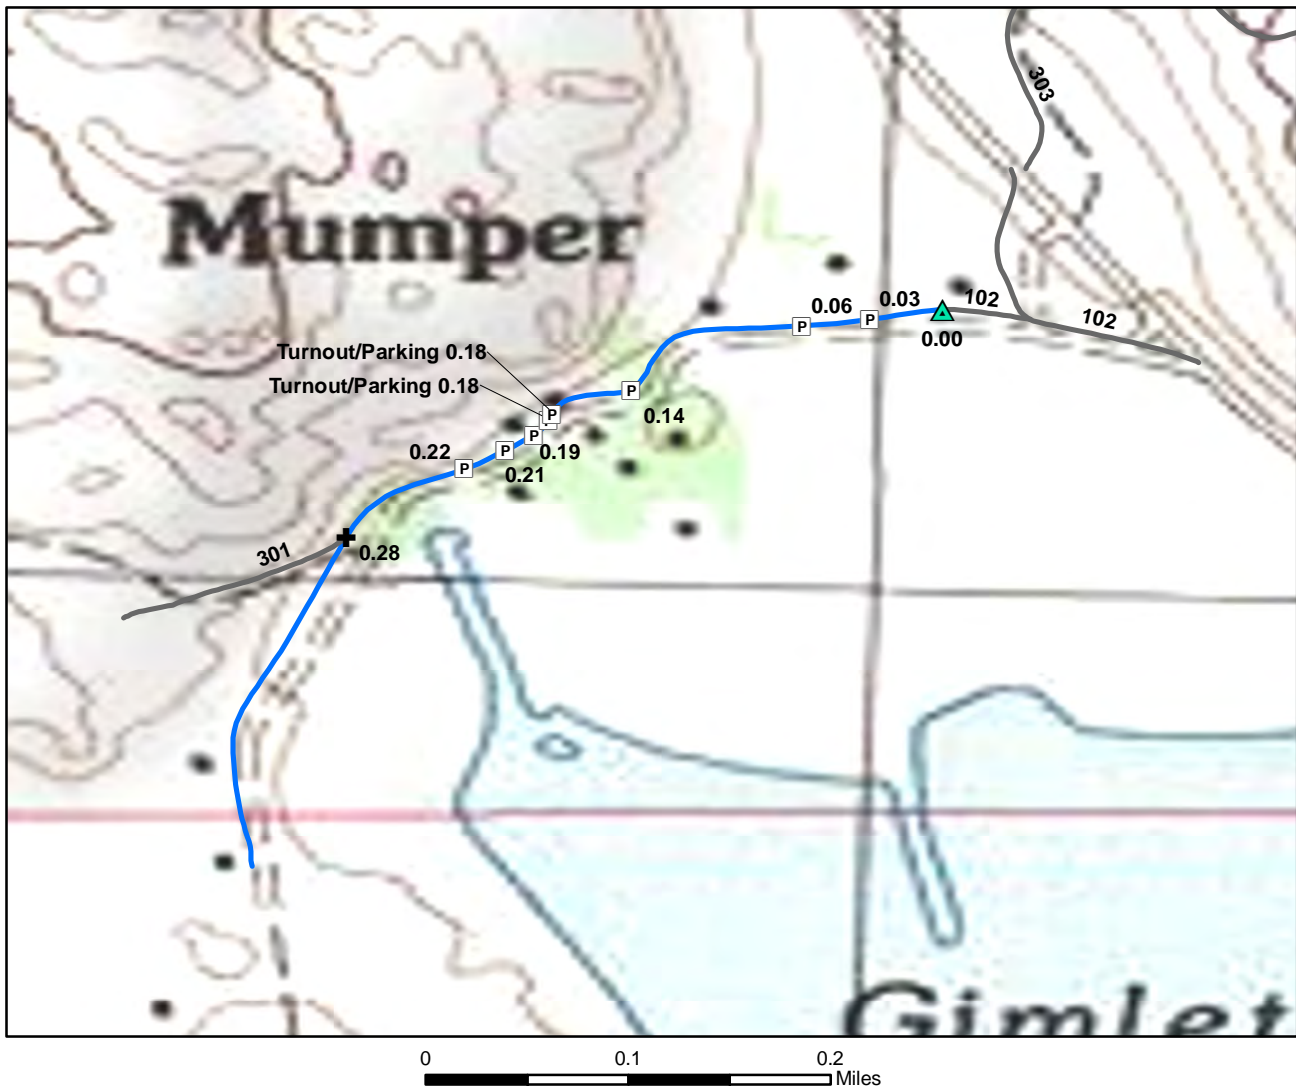
ROUTE: 102 Vistor Center Access Road TOTAL LENGTH: 0.18 Miles

Section Number	001	002			
Section Length (miles)	0.14	0.03			
Inspection Date	5/13/2008	5/13/2008			
Section Information					
Surface Type	Gravel	Gravel			
Number of Lanes	1	1			
Roadway Width (feet)	14	14			
Roadway Condition Information					
Condition	Excellent	Excellent			
Remaining Service Life (years)	9	10			
Cost Estimate	\$0	\$0			
CRV	\$101100	\$23000

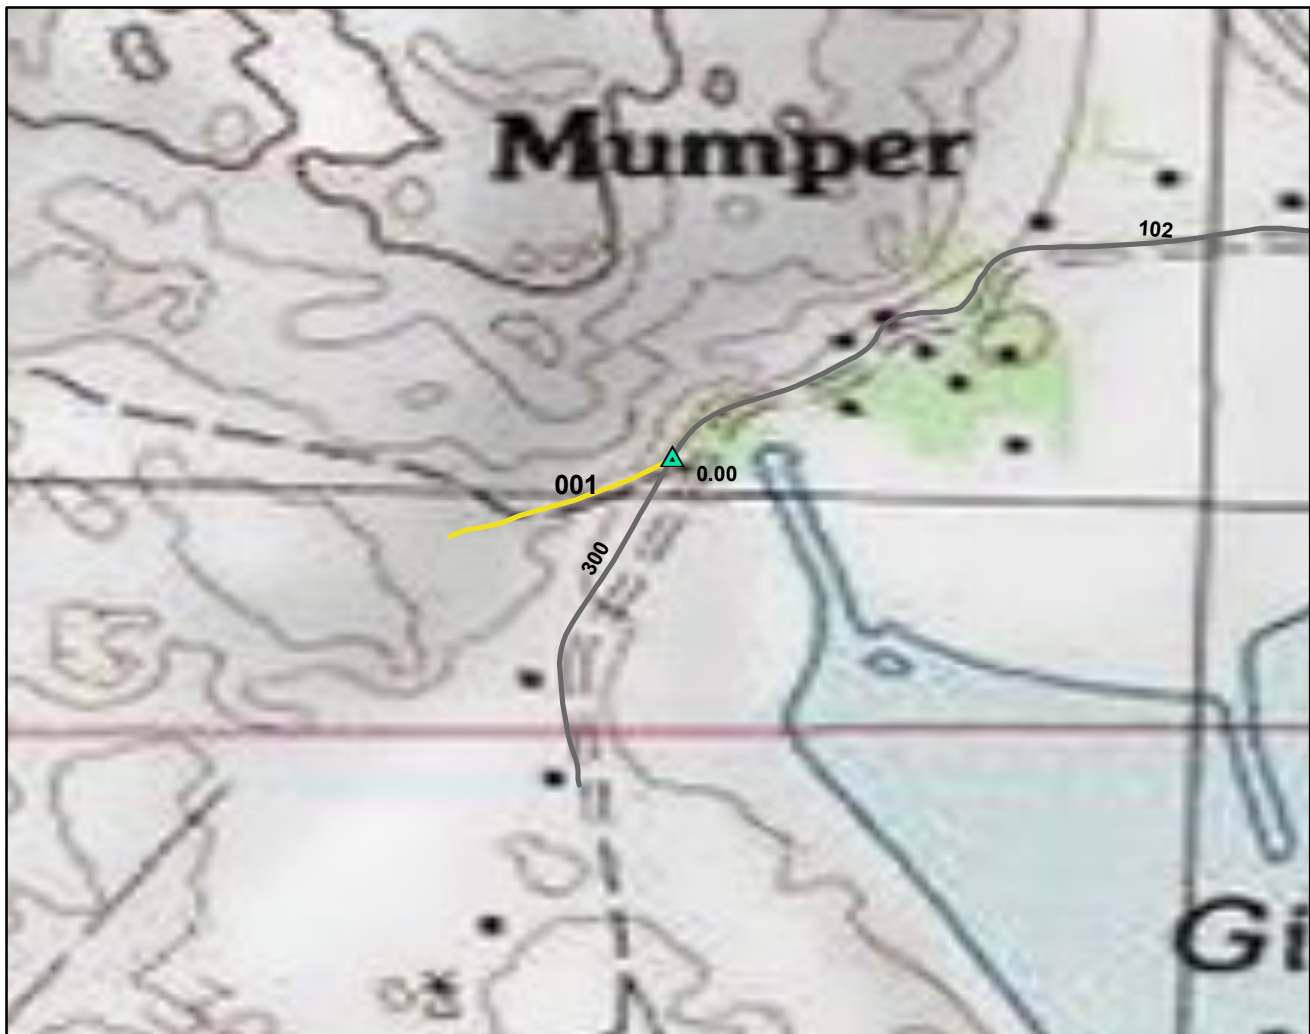
ROUTE: 300 Main HQ Service Road TOTAL LENGTH: 0.44 Miles

Section Number	001				
Section Length (miles)	0.44				
Inspection Date	5/13/2008				
Section Information					
Surface Type	Gravel				
Number of Lanes	1				
Roadway Width (feet)	14				
Roadway Condition Information					
Condition	Excellent				
Remaining Service Life (years)	9				
Cost Estimate	\$0				
CRV	\$307100

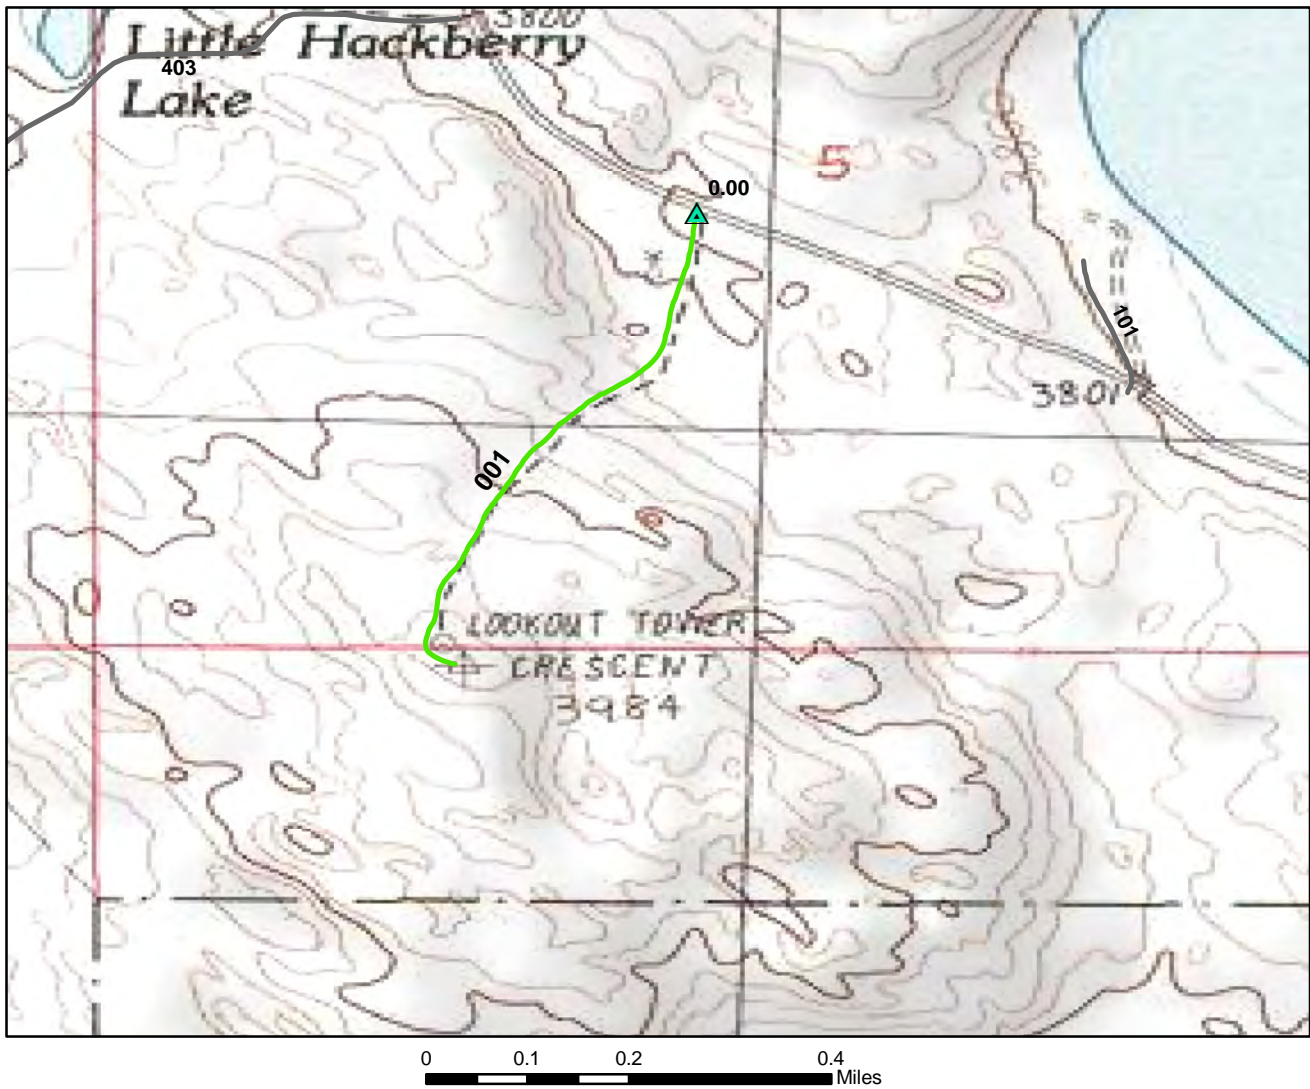
Section Number	001				
Section Length (miles)	0.09				
Inspection Date	5/13/2008				
Section Information					
Surface Type	Native				
Number of Lanes	1				
Roadway Width (feet)	10				
Roadway Condition Information					
Condition	Fair				
Remaining Service Life (years)	3				
Cost Estimate	\$200				
CRV	\$33500

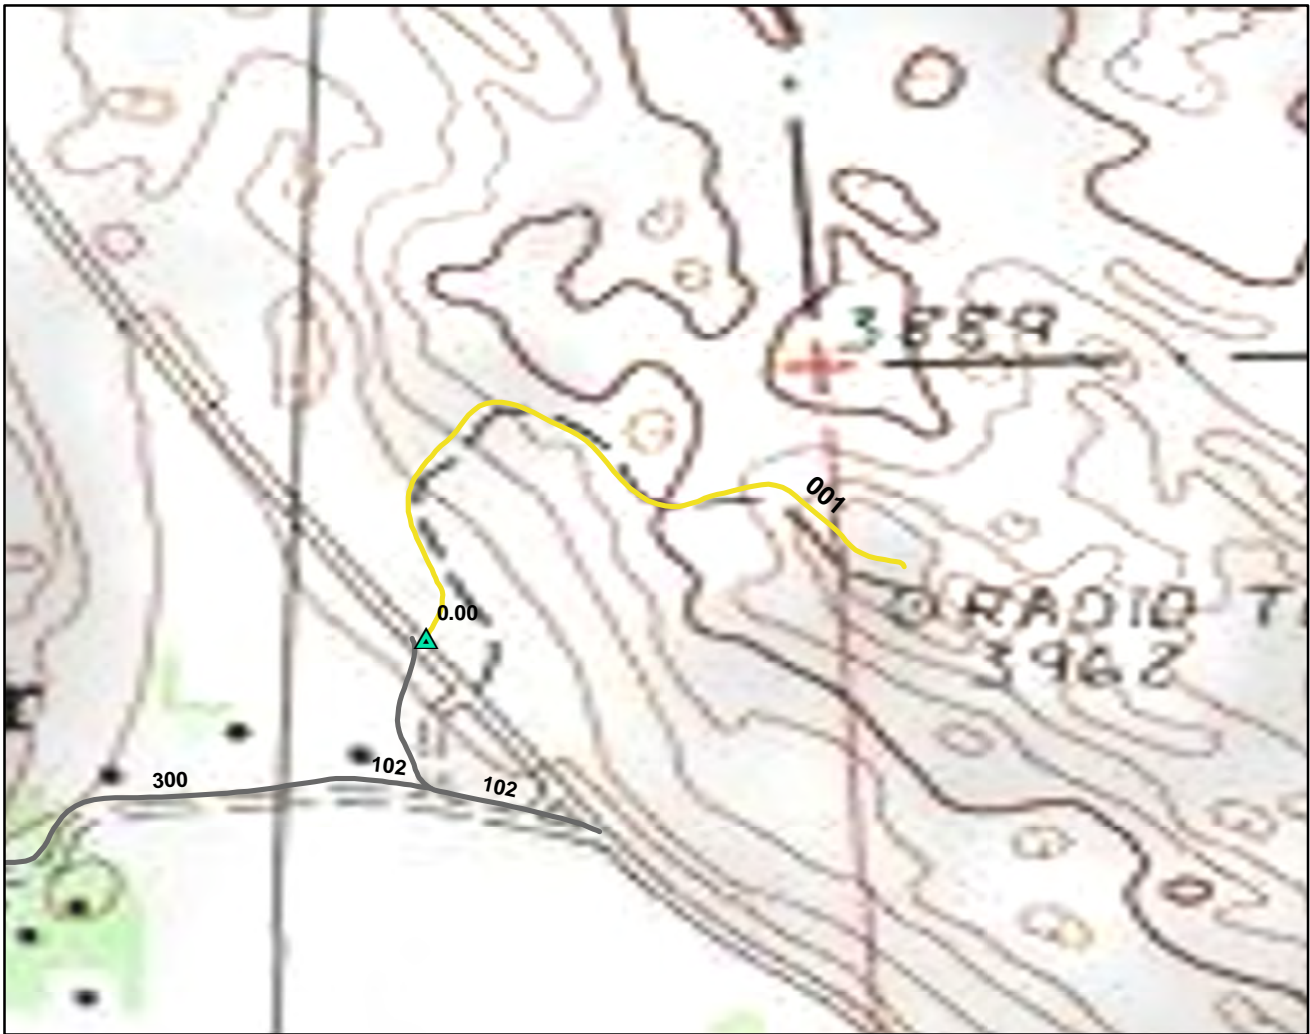
ROUTE: 302 South Tower Road TOTAL LENGTH: 0.52 Miles

Section Number	001				
Section Length (miles)	0.52				
Inspection Date	5/14/2008				
Section Information					
Surface Type	Primitive				
Number of Lanes	1				
Roadway Width (feet)	10				
Roadway Condition Information					
Condition	Good				
Remaining Service Life (years)	5				
Cost Estimate	\$200				
CRV	\$0

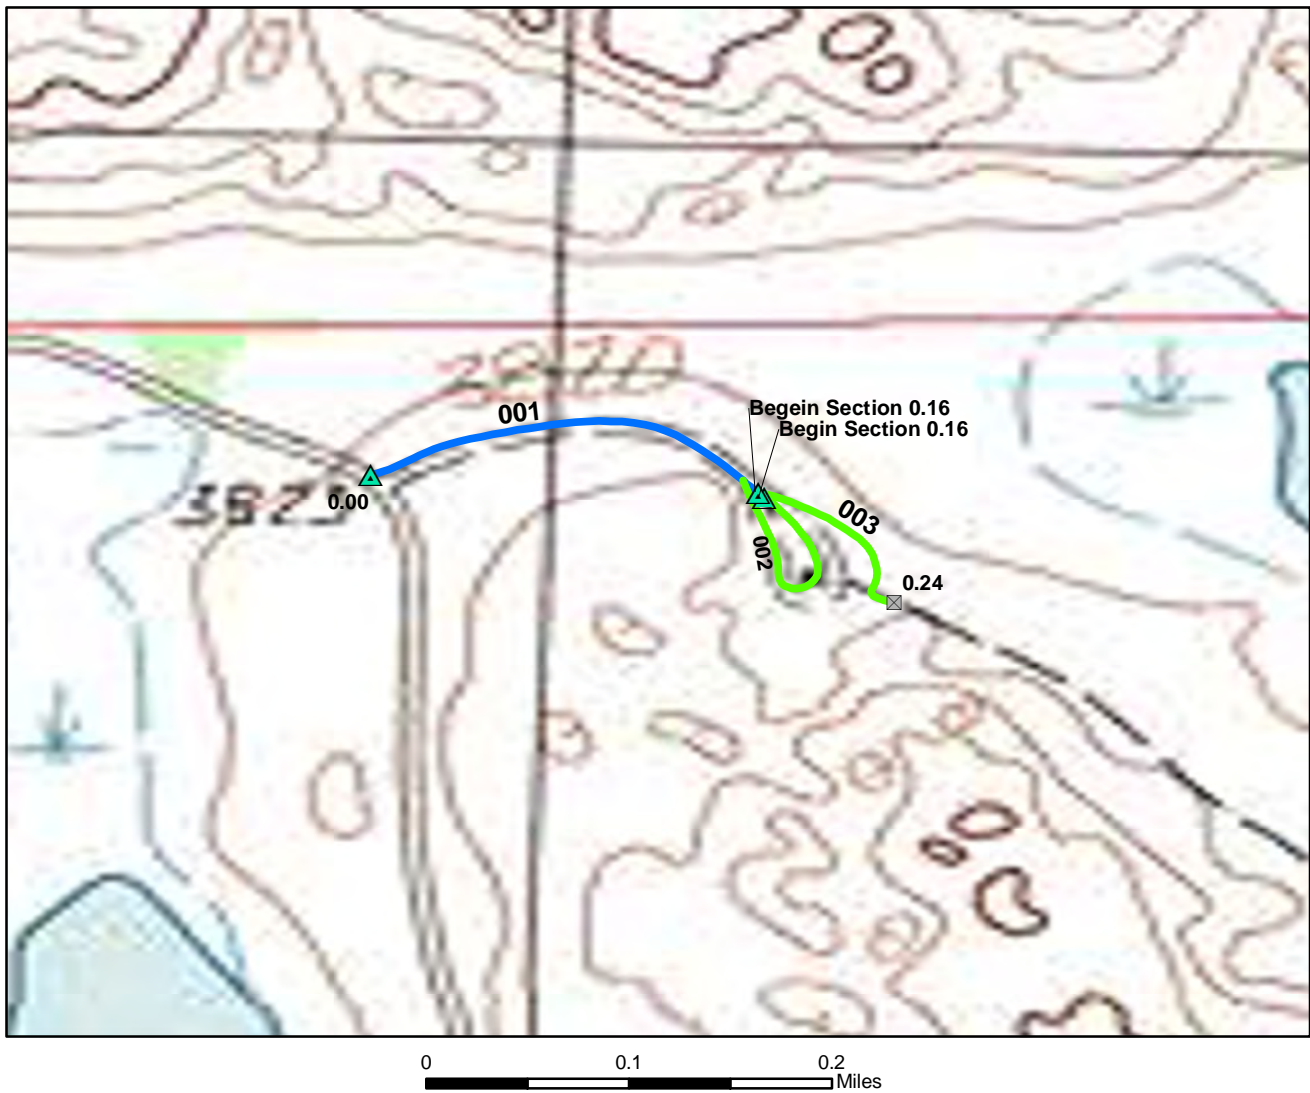
ROUTE: 406 West Island Road TOTAL LENGTH: 0.47 Miles

Section Number	001				
Section Length (miles)	0.47				
Inspection Date	5/14/2008				
Section Information					
Surface Type	Primitive				
Number of Lanes	1				
Roadway Width (feet)	8				
Roadway Condition Information					
Condition	Good				
Remaining Service Life (years)	5				
Cost Estimate	\$200				
CRV	\$0

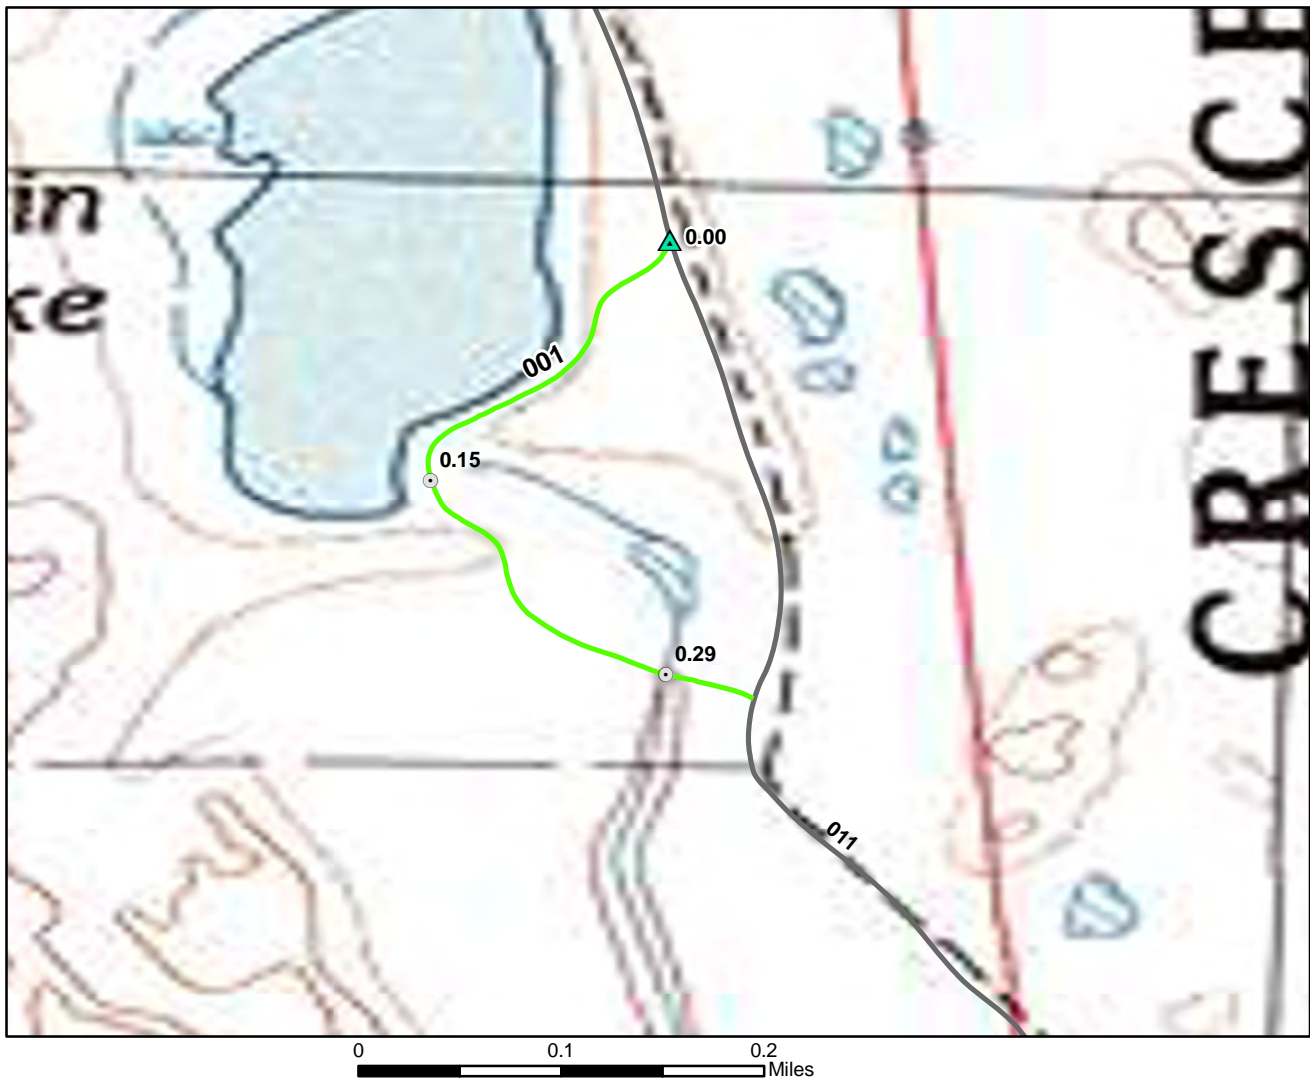
ROUTE: 409 West Smith Road

Section Number	001	002			
Section Length (miles)	0.96	0.49			
Inspection Date	5/14/2008	5/14/2008			
Section Information					
Surface Type	Primitive	Primitive			
Number of Lanes	1	1			
Roadway Width (feet)	8	8			
Roadway Condition Information					
Condition	Good	Good			
Remaining Service Life (years)	5	5			
Cost Estimate	\$400	\$200			
CRV	\$0	\$0

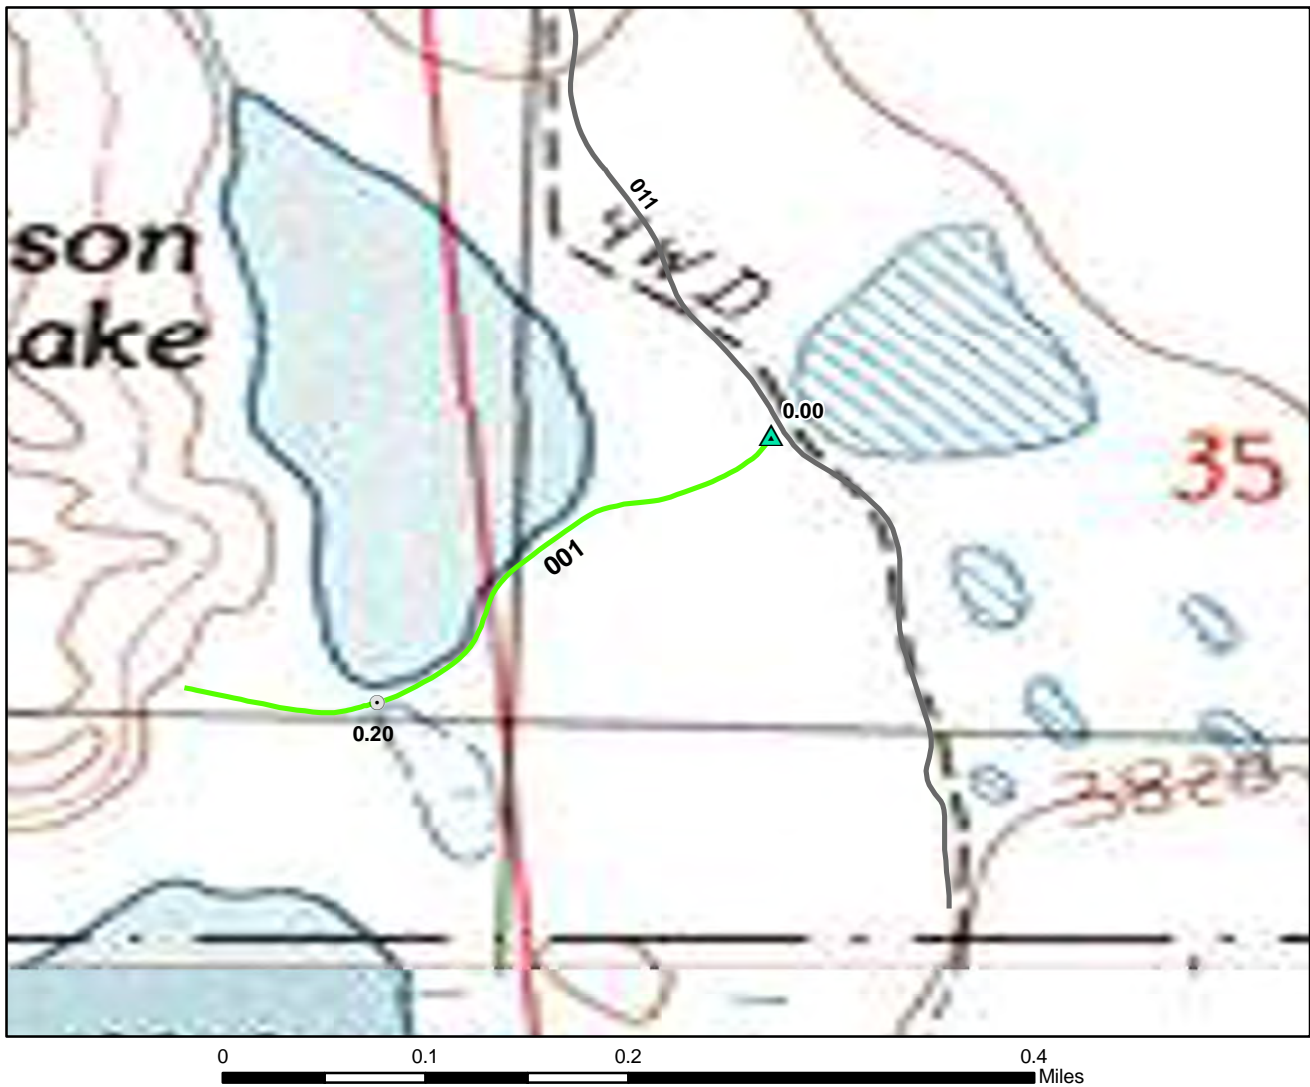
ROUTE: 411 Perrin Lake Road TOTAL LENGTH: 0.33 Miles

Section Number	001				
Section Length (miles)	0.33				
Inspection Date	5/14/2008				
Section Information					
Surface Type	Primitive				
Number of Lanes	1				
Roadway Width (feet)	8				
Roadway Condition Information					
Condition	Good				
Remaining Service Life (years)	7				
Cost Estimate	\$100				
CRV	\$0

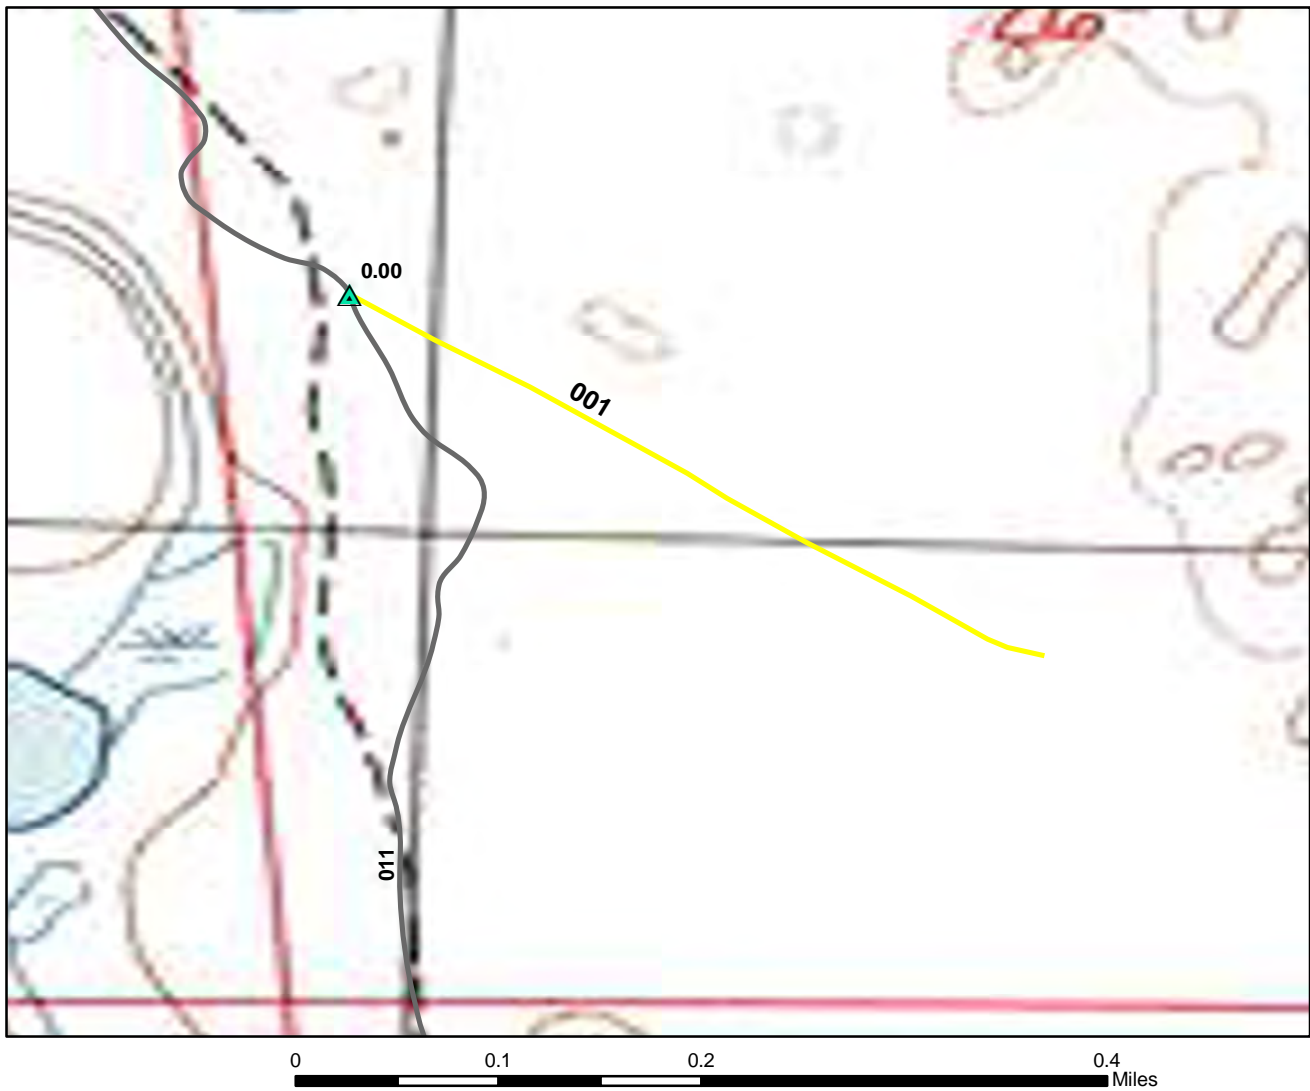
ROUTE: 412 Harrison Lake Road TOTAL LENGTH: 0.28 Miles

Section Number	001				
Section Length (miles)	0.28				
Inspection Date	5/14/2008				
Section Information					
Surface Type	Primitive				
Number of Lanes	1				
Roadway Width (feet)	8				
Roadway Condition Information					
Condition	Good				
Remaining Service Life (years)	7				
Cost Estimate	\$100				
CRV	\$0

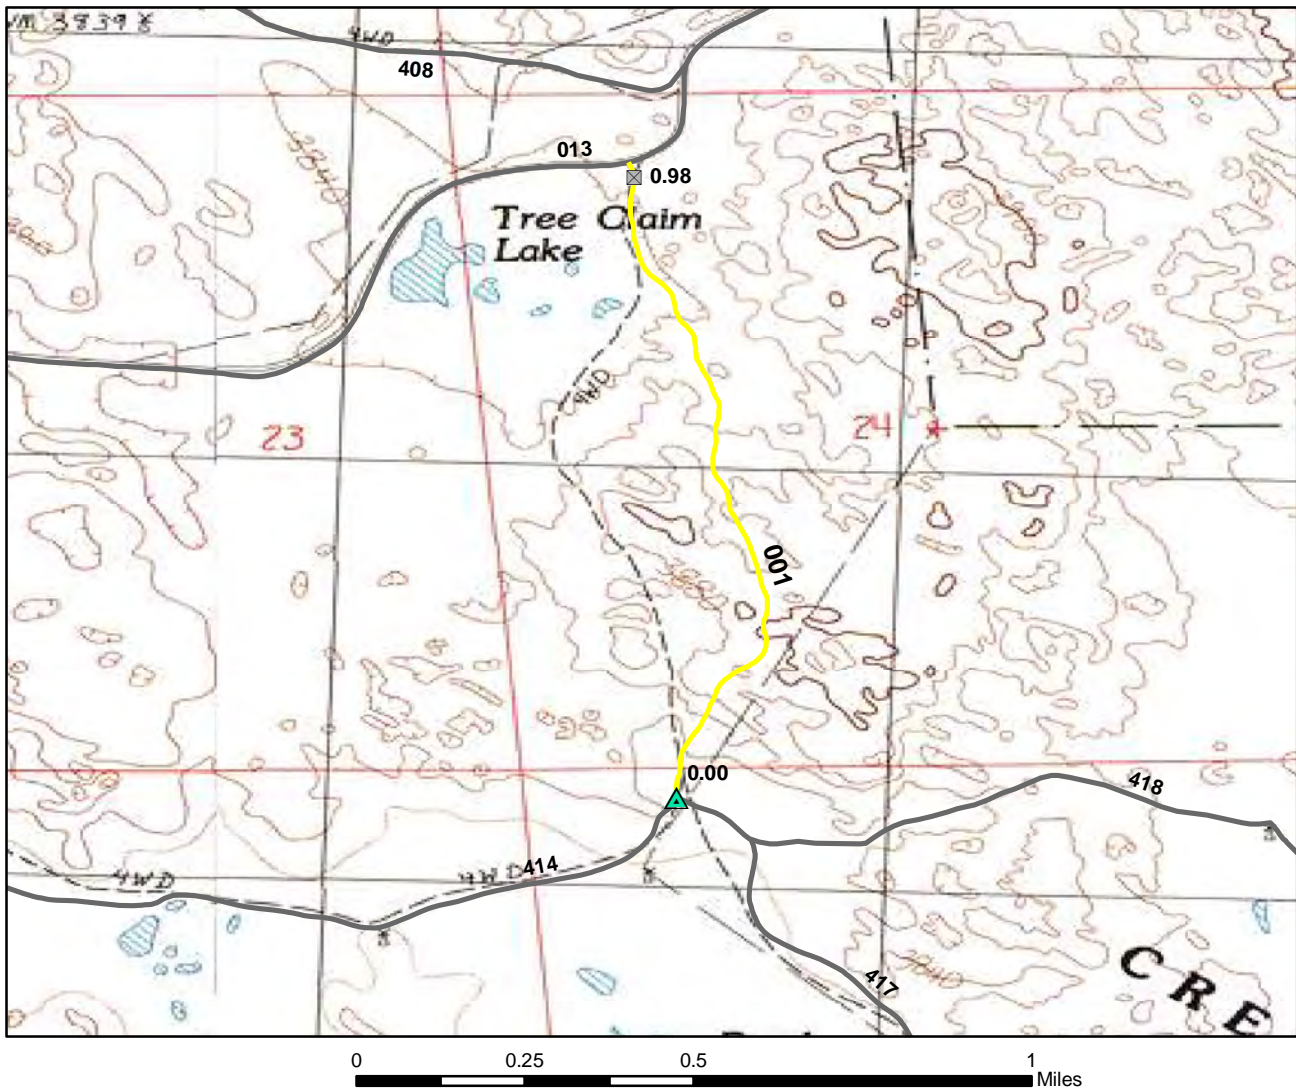
ROUTE: 414 Boyd Road

Section Number	001				
Section Length (miles)	1.46				
Inspection Date	5/14/2008				
Section Information					
Surface Type	Native				
Number of Lanes	1				
Roadway Width (feet)	8				
Roadway Condition Information					
Condition	Good				
Remaining Service Life (years)	7				
Cost Estimate	\$2600				
CRV	\$529700

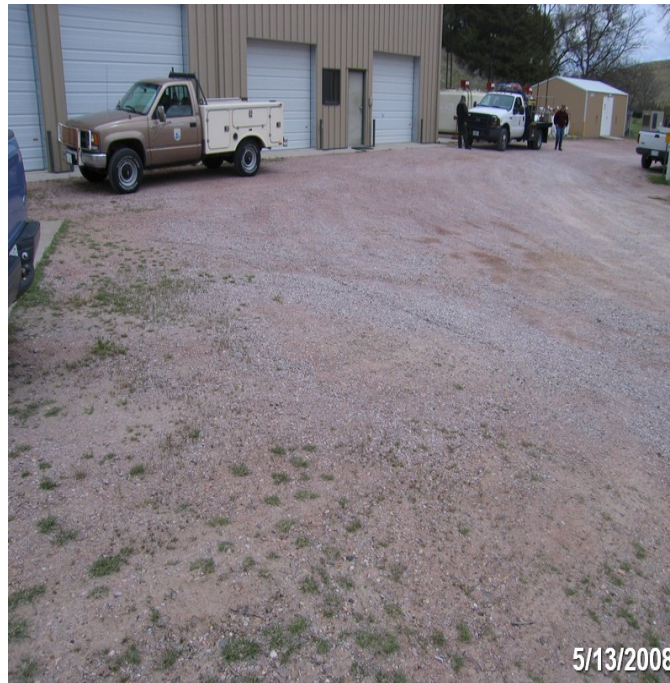
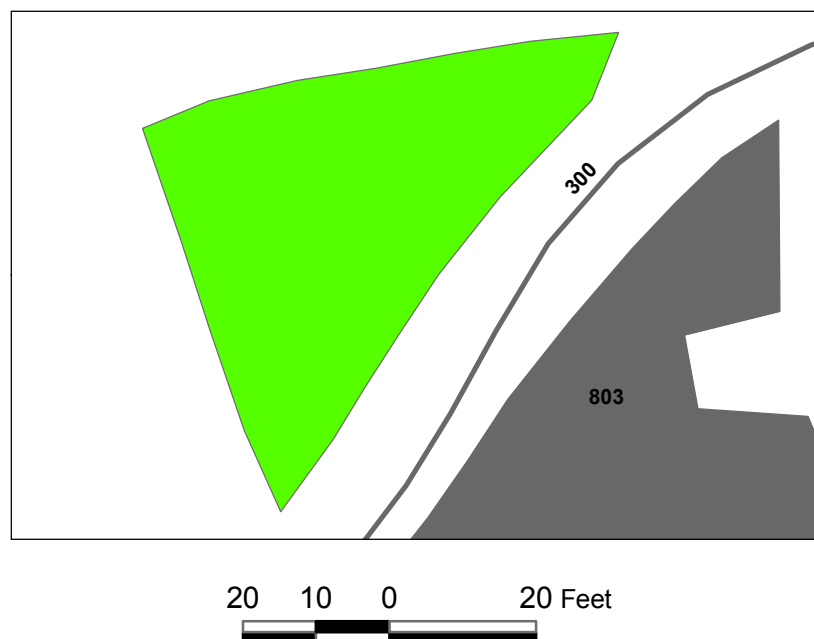
Route 802: Service Parking 3

Asset Number	Date Visited	Surface Type	Area (sq ft)	Condition	Cost to Improve
10030365	5/13/2008	Gravel	1459	Good	\$200

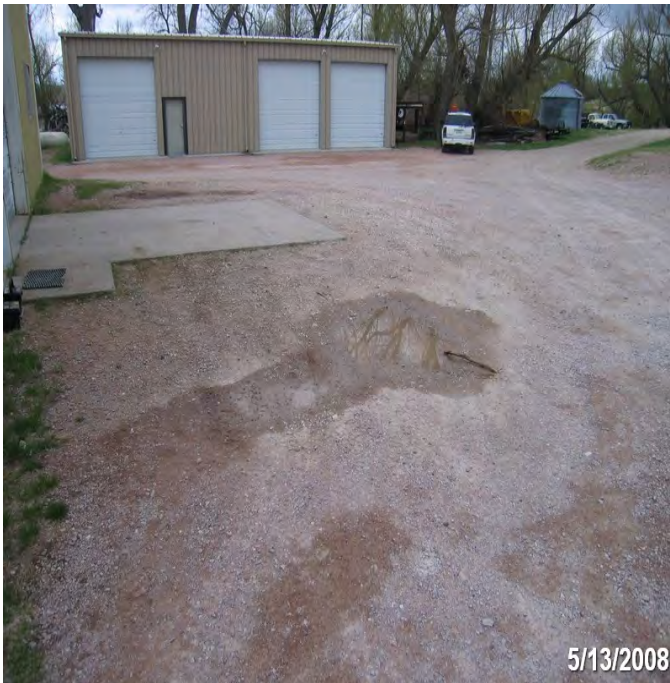
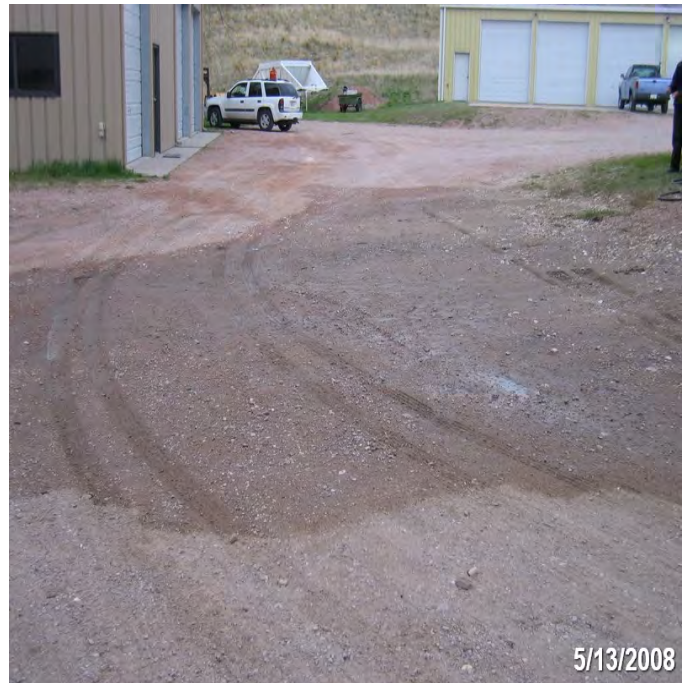
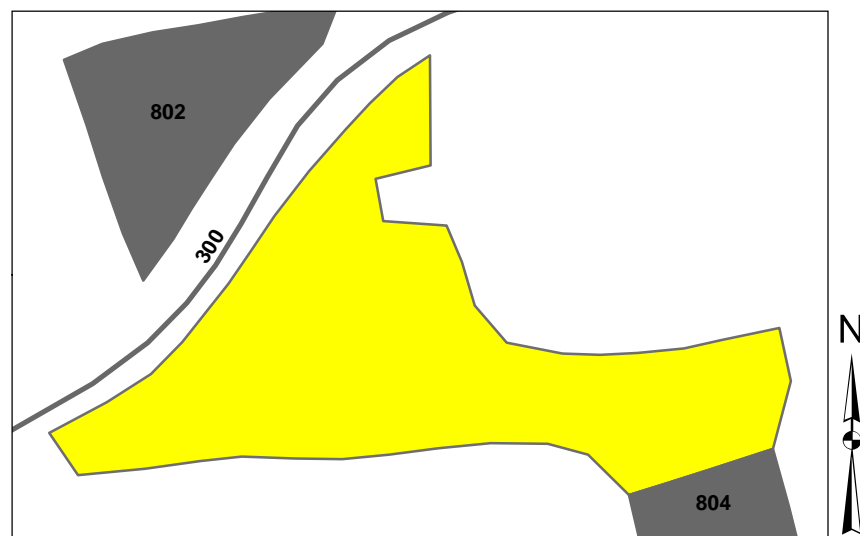
Route 803: Service Parking 4

Asset Number	Date Visited	Surface Type	Area (sq ft)	Condition	Cost to Improve
10030365	5/13/2008	Gravel	5067	Fair	\$1400

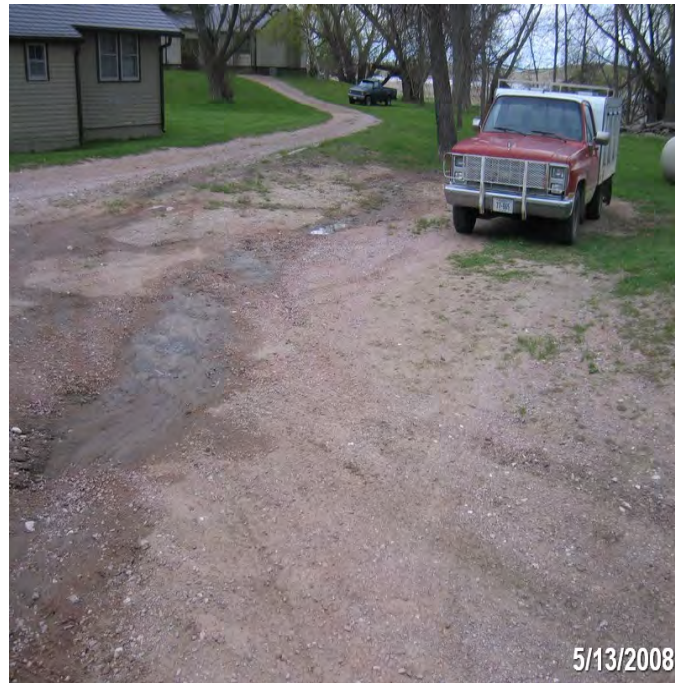
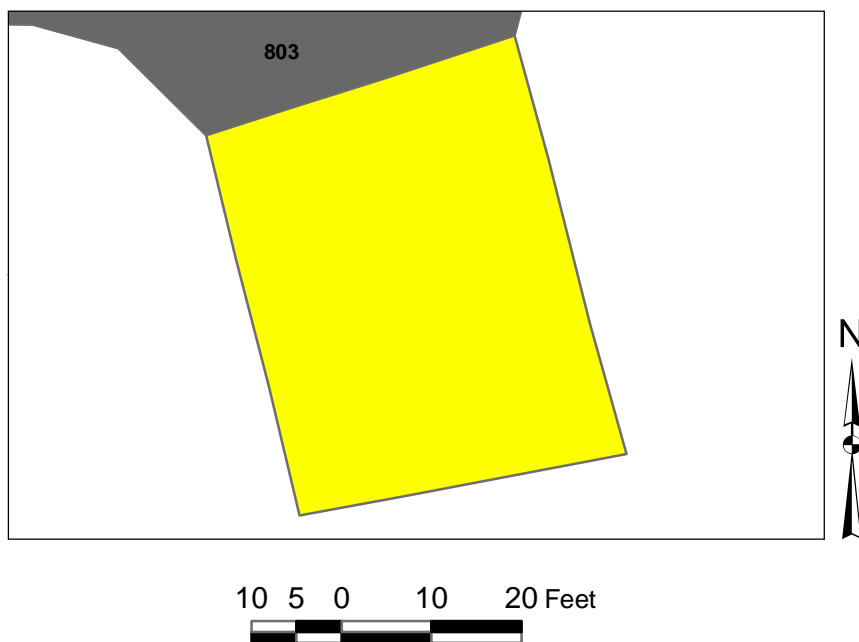
Route 804: Service Parking 5

Asset Number	Date Visited	Surface Type	Area (sq ft)	Condition	Cost to Improve
10030365	5/13/2008	Native	1241	Fair	\$300

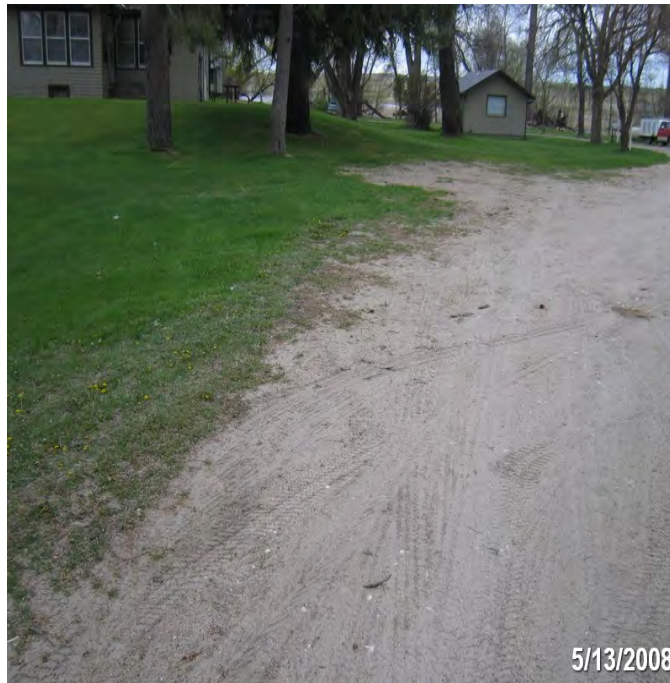
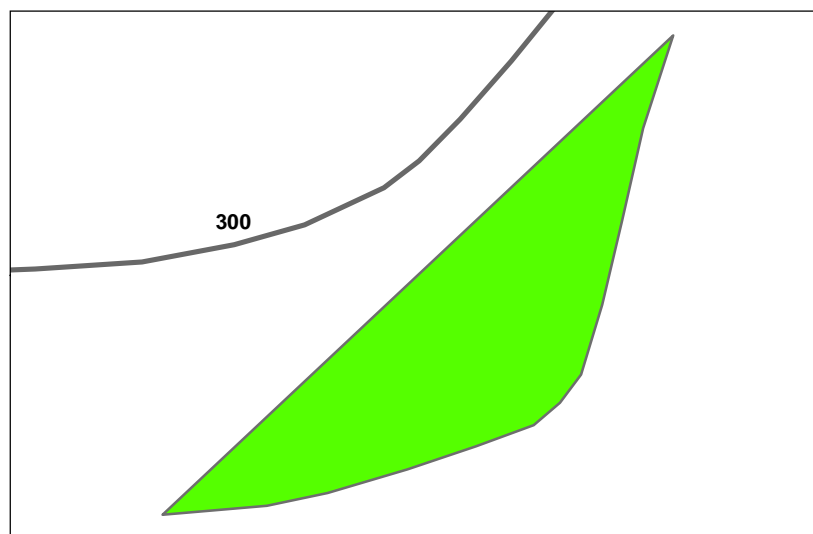
Route 805: Service Parking 6

Asset Number	Date Visited	Surface Type	Area (sq ft)	Condition	Cost to Improve
10030365	5/13/2008	Native	1161	Good	\$200

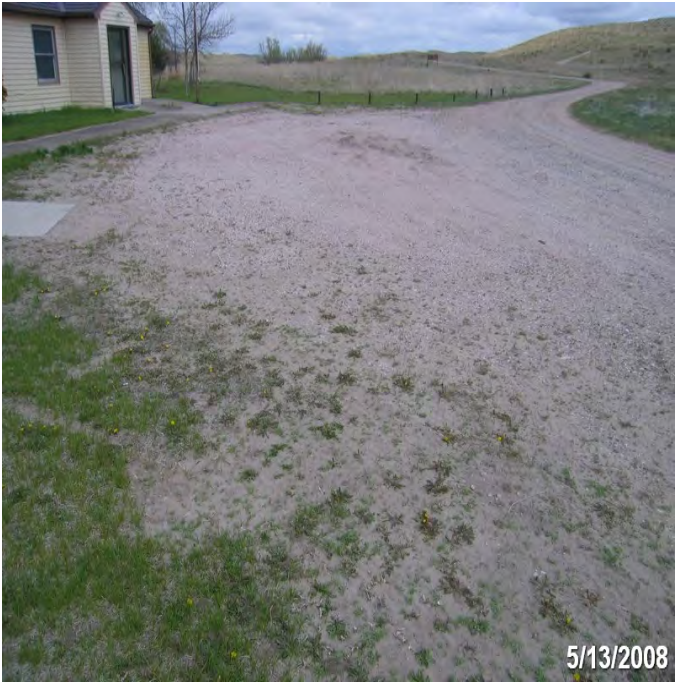
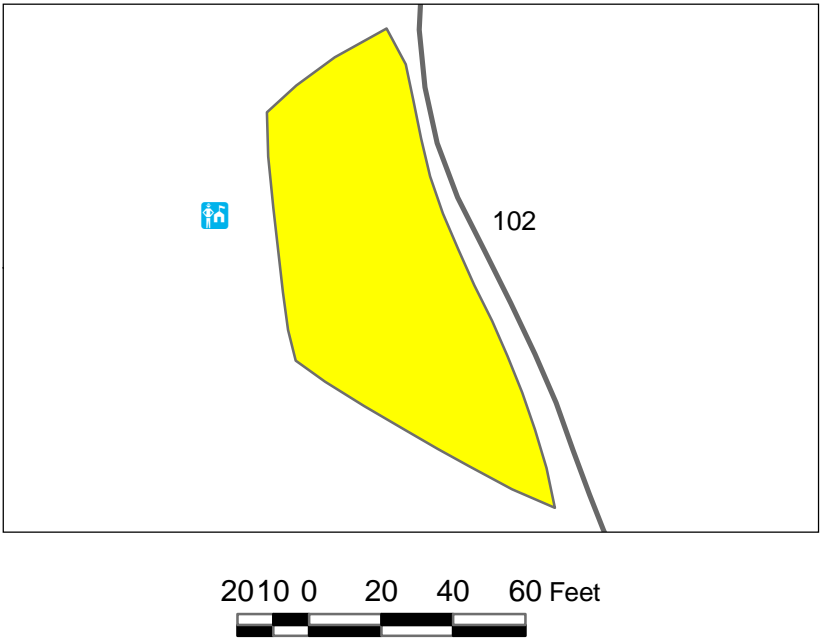
Route 901: Headquarters Parking

Asset Number	Date Visited	Surface Type	Area (sq ft)	Condition	Cost to Improve
10030375	5/13/2008	Gravel	3962	Fair	\$1100

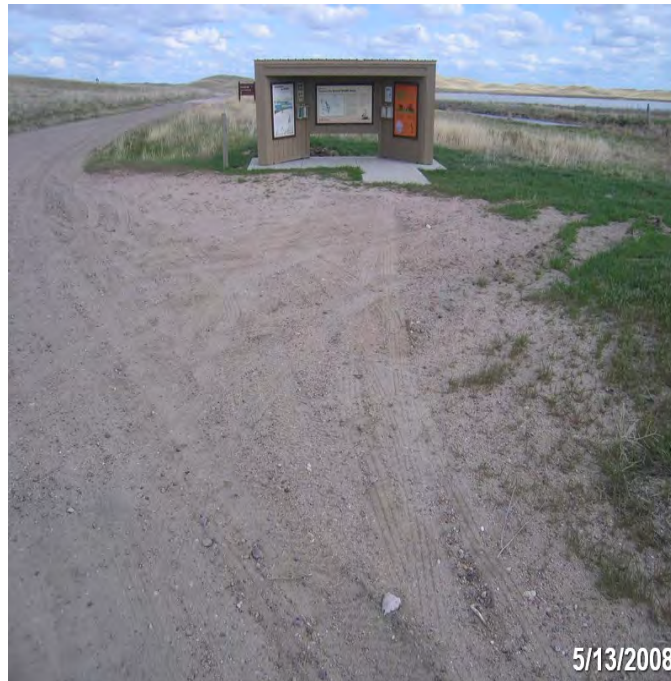
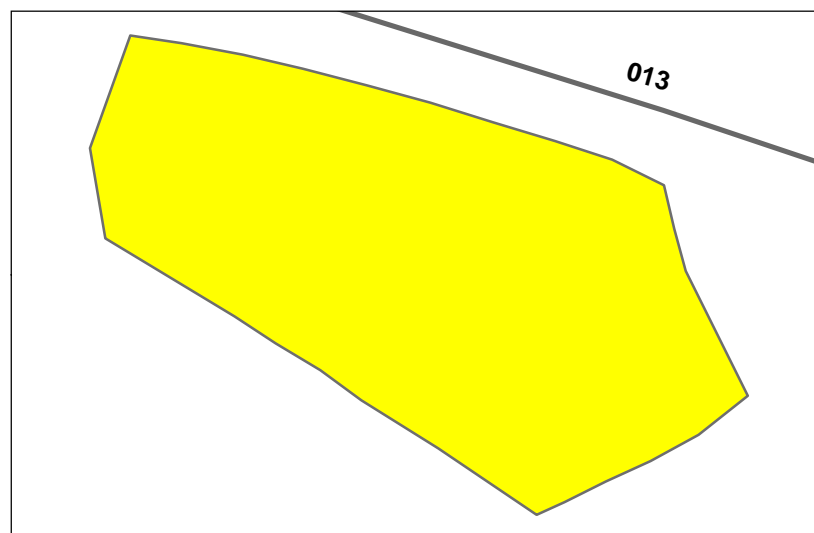
Route 902: West Mail Road Kiosk Parking

Asset Number	Date Visited	Surface Type	Area (sq ft)	Condition	Cost to Improve
10030374	5/13/2008	Gravel	1243	Fair	\$300
